SUMMARY

1234 Main Street Fort Collins CO
80525
Buyer Name
04/11/2023 9:00AM

Alex Choe
InterNACHI #16112102
ProCheck Inspection Services
(970) 227-6898
maria@procheckinspect.com

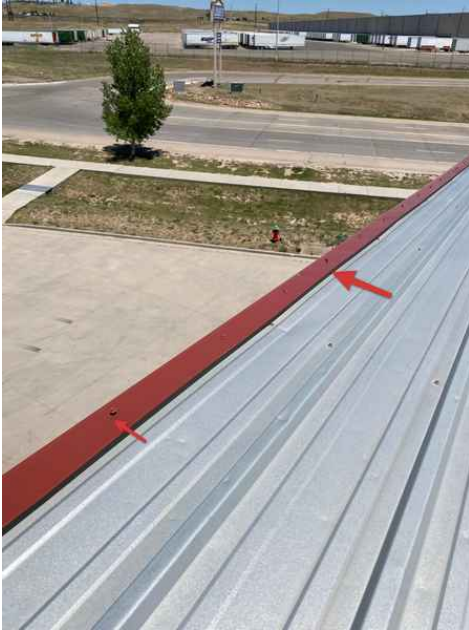
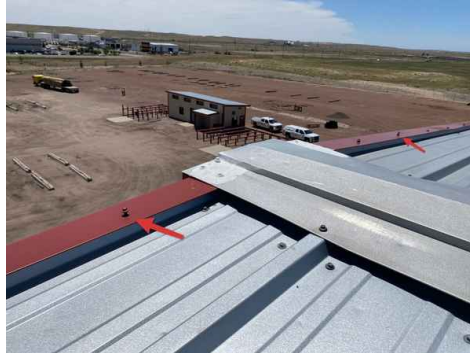
2.1.1 COVERINGS

LOOSE SCREWS

The roof covering is in acceptable condition overall. Several screws need to be secured at the drip edge flashing at the North, West and South side of the warehouse.

Contact a qualified professional.

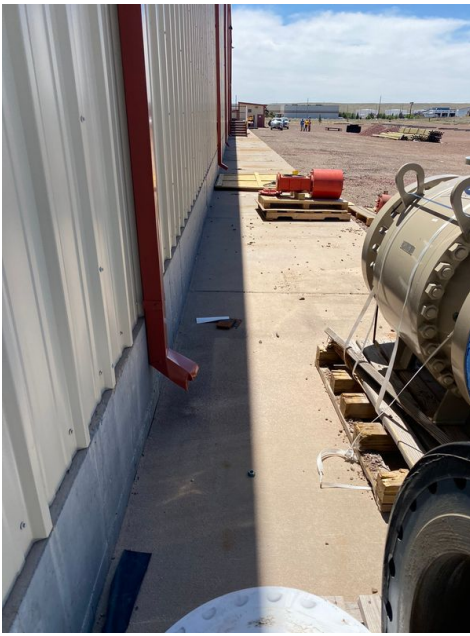
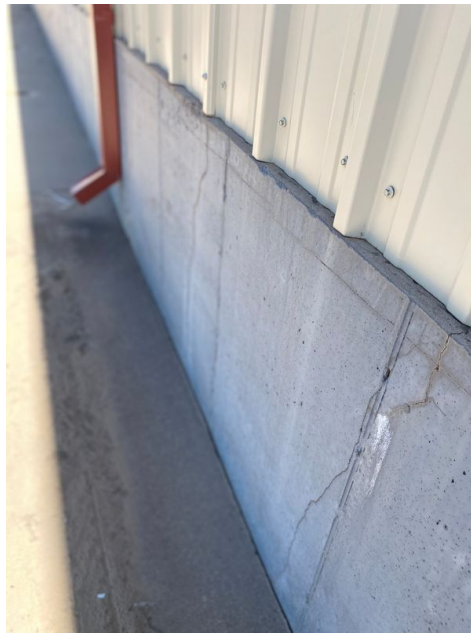
2.4.1 DRAINAGE SYSTEMS

DOWNSPOUT EXTENSIONS

Recommend that downspout extensions be installed to divert the runoff away from the structure.

Contact a qualified professional.

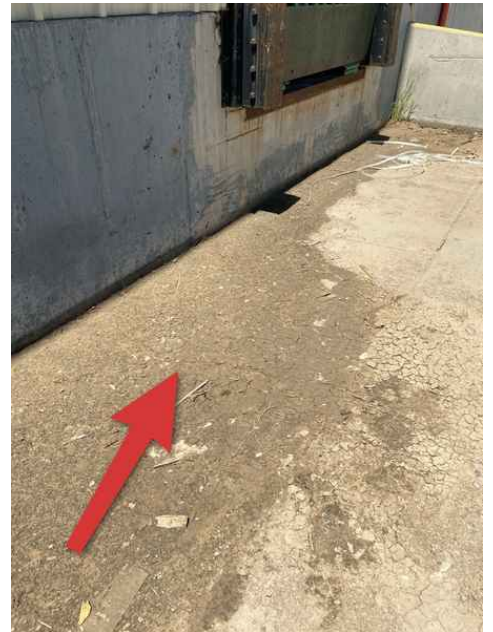
2.4.2 DRAINAGE SYSTEMS

NO DRAIN FLOOR AT THE TRAILER RAMPS AT THE WEST SIDE.

There are no visible floor drains installed at the trailer ramp near the foundation wall. This could allow for settlement on the driveway when excessive water accumulation and freeze/thaw damage.

Recommend that a qualified service provider determine if floor drains are present or need to be installed.

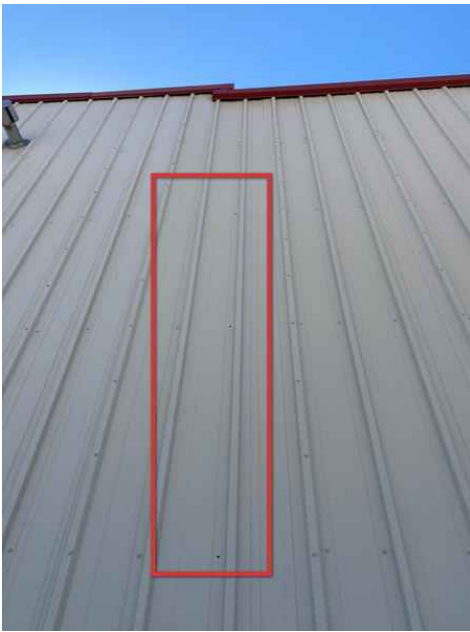
East

MINOR DAMAGES

Several screws are missing at a few panels on the east side of the warehouse.

Impact damage is noted at a few of the panels on the east and north side of the warehouse.

Contact a qualified professional.

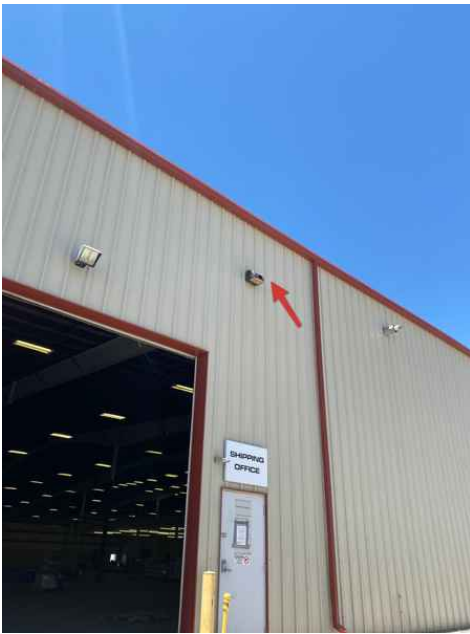
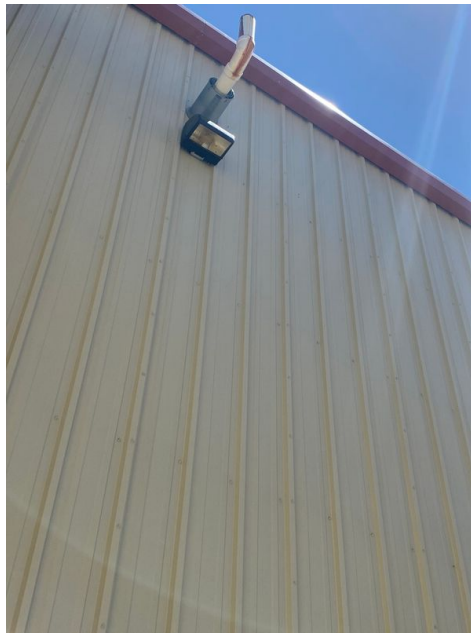
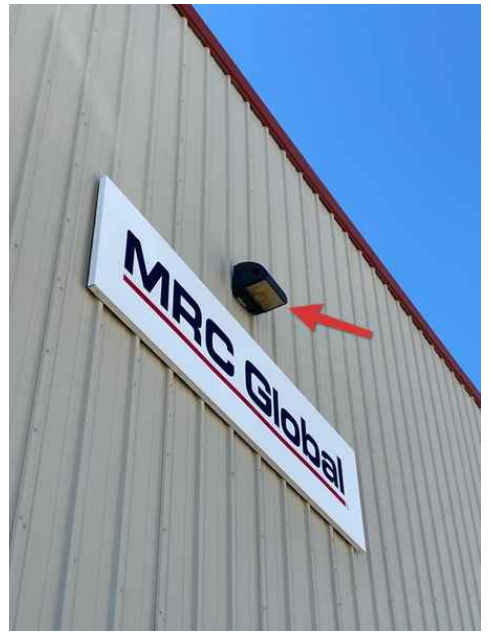
3.7.1 EXTERIOR LIGHTING
DAMAGE LIGHT FIXTURES

There are 3 exterior light fixtures that the housing is cracked and/or the light bulbs need to be replaced.

Recommendation
Contact a qualified professional.

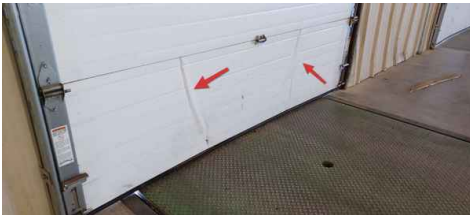
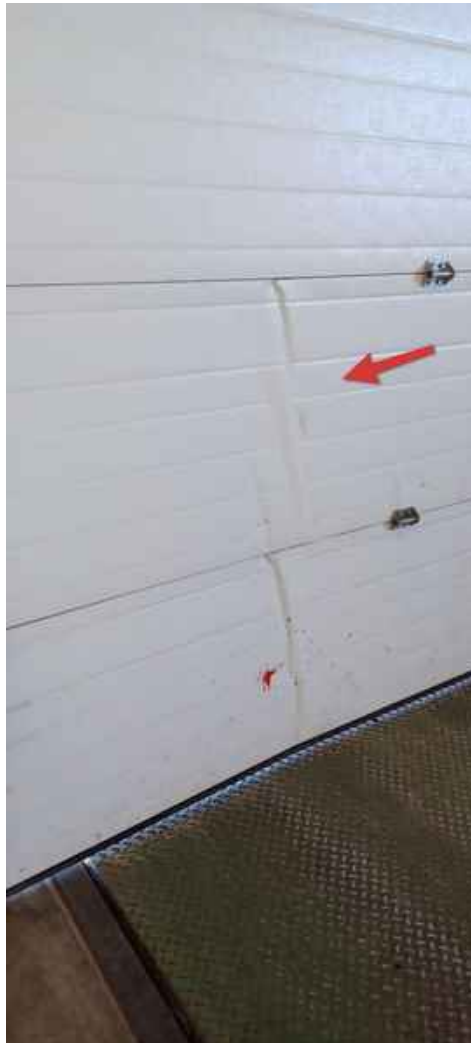
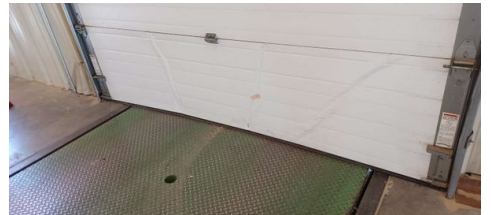
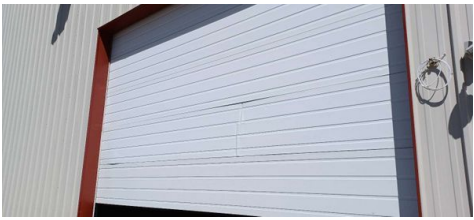
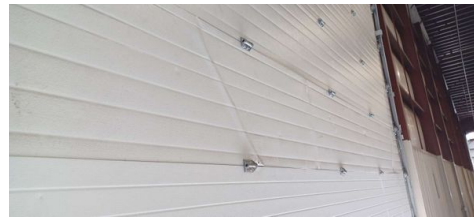
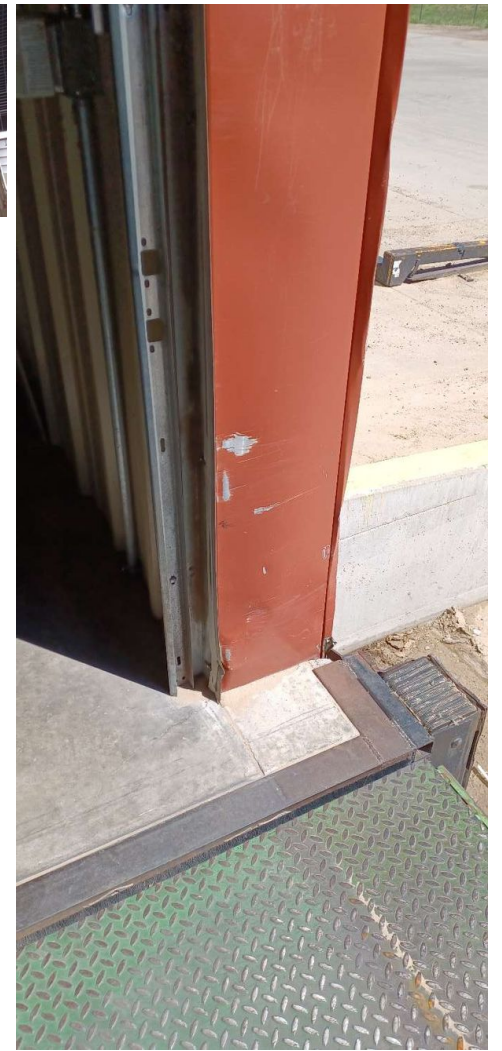
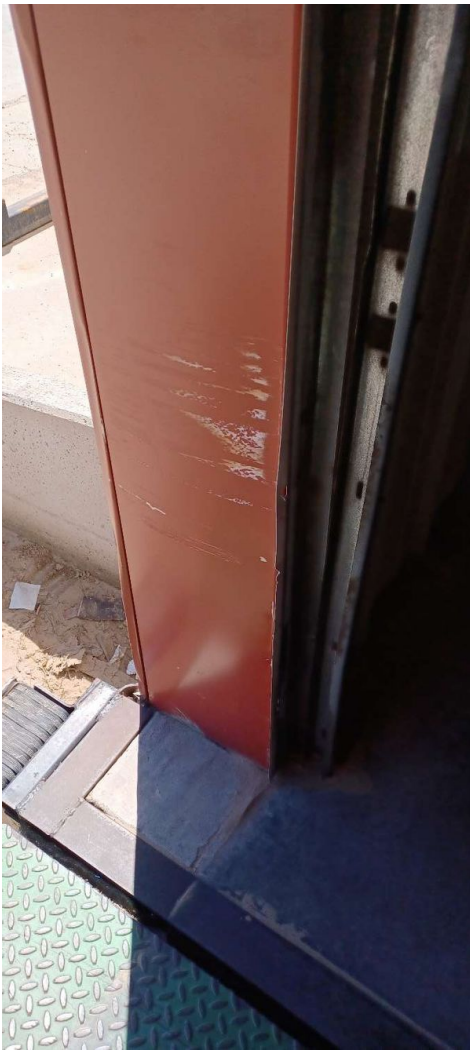
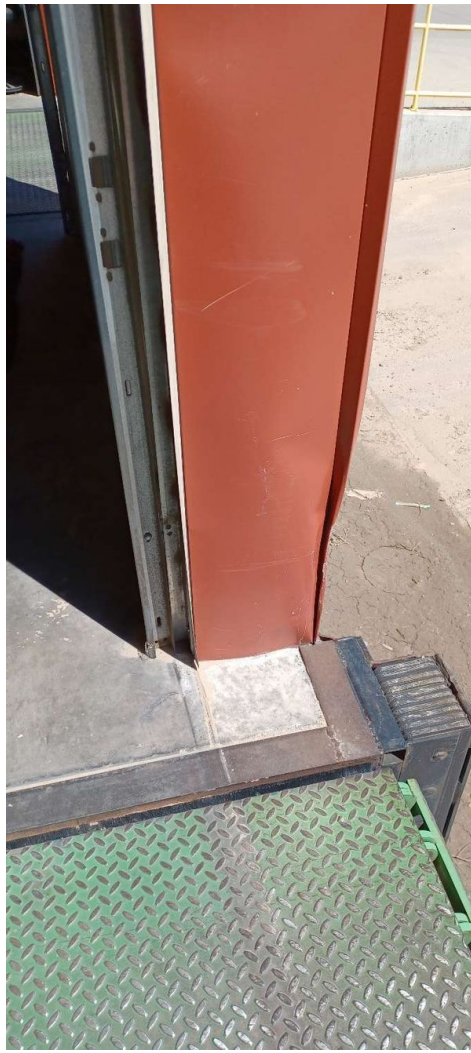
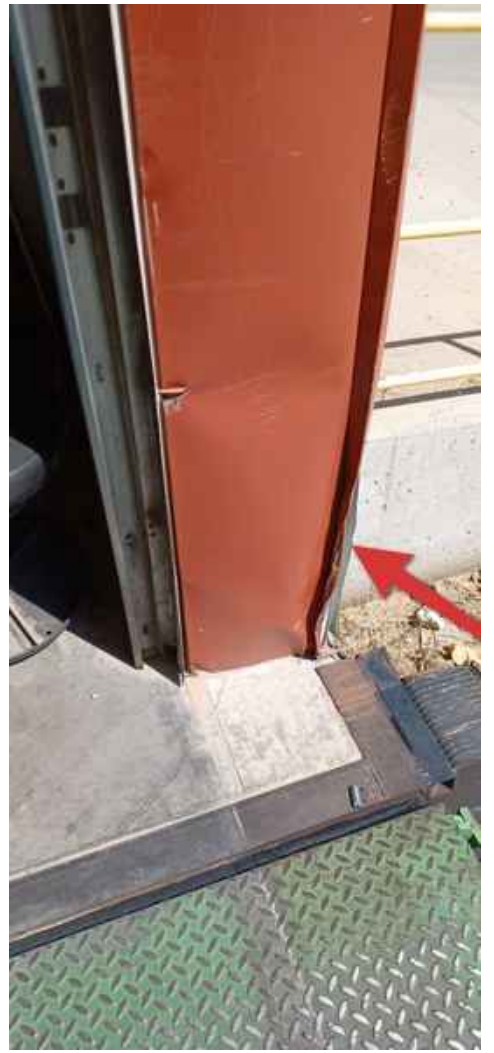
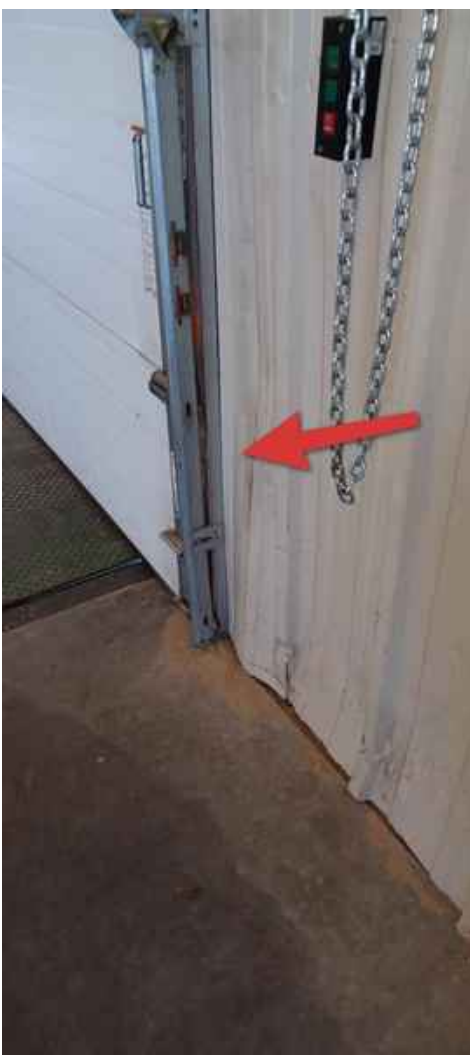
4.1.1 GARAGE DOOR (S) IMPACT DAMAGE-COSMETIC

Impact damage is noted at the garage door panels and surrounding areas and is consistent with warehouse with forklift operation. The damage does not appear to effect the doors function.

Recommendation
Contact a qualified professional.

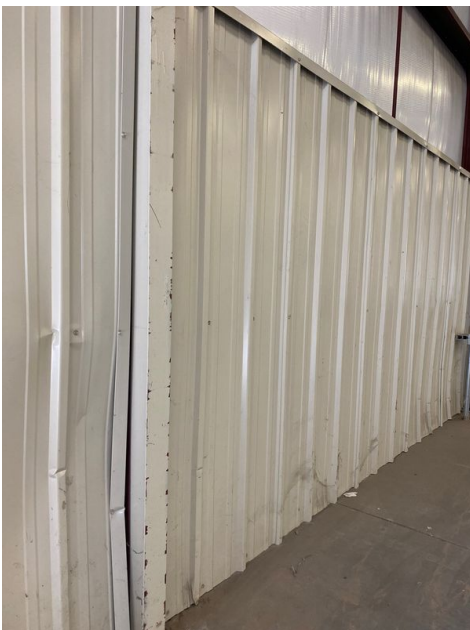
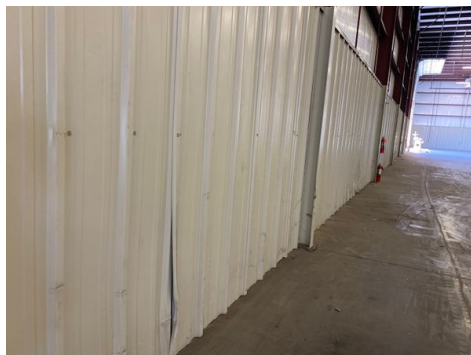
4.2.1 INTERIOR PANELS

IMPACT DAMAGE

Impact damage is noted at a few metal panels at the west side of the warehouse.

Recommendation
Contact a qualified professional.

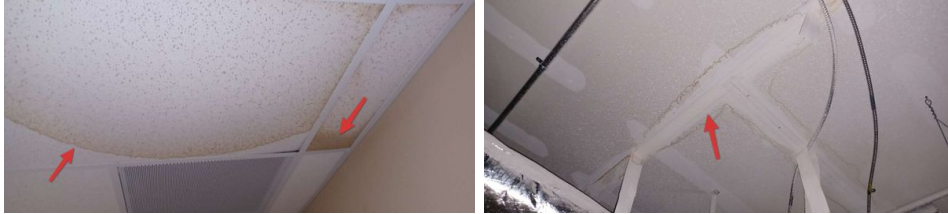
5.1.1 CEILINGS

OFFICE CEILING WATER DAMAGE

In the northeast office, the ceiling panels show signs of previous water leak.

The source of the leak is above the sheetrock of the utility space above the ceiling panels and could not be accessed. The leak could be from the roof and may have been previously addressed.

A rubber coating is noted at the roof covering above the office.

Contact a qualified professional.

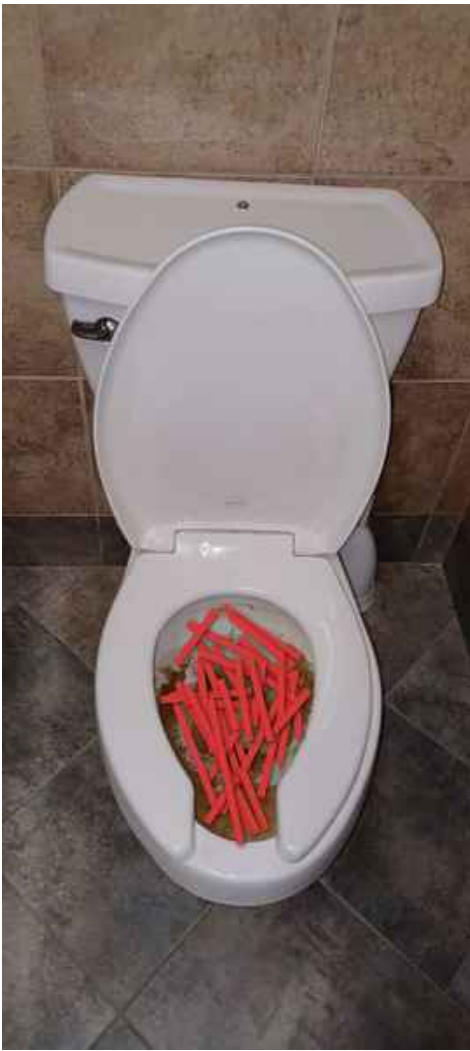
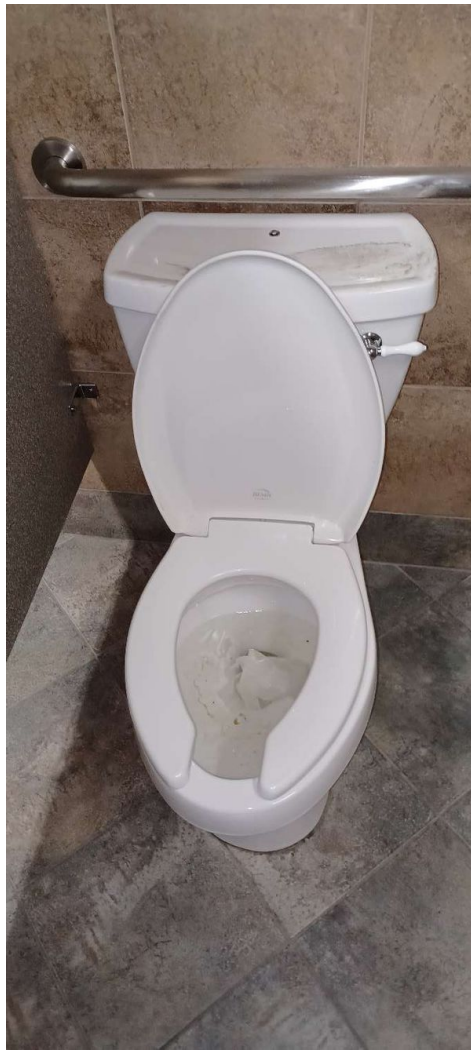
5.7.1 BATHROOMS

WOMENS RESTROOM

The toilets in the women's restroom were clogged and not functional at the time of inspection.

It is recommended that a qualified contractor evaluate and determine the best options for repair.

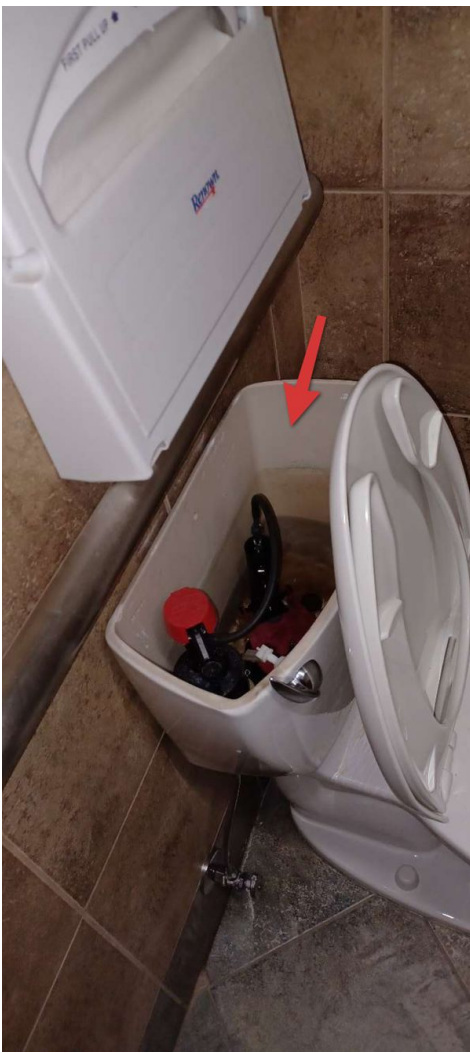
5.7.2 BATHROOMS
MENS RESTROOM

The tank lid for the toilet is missing at the time of inspection.

This should be replaced as needed.

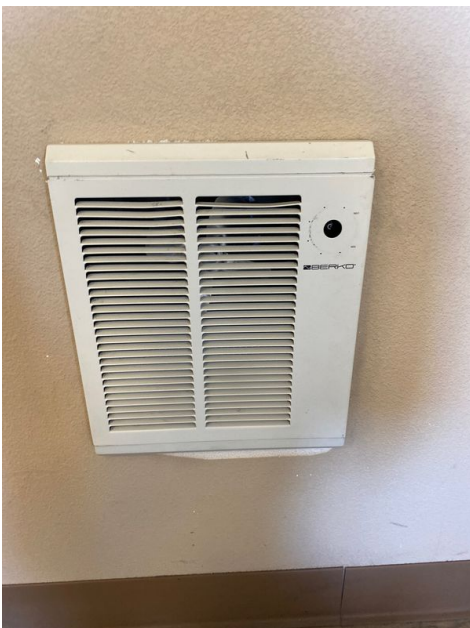
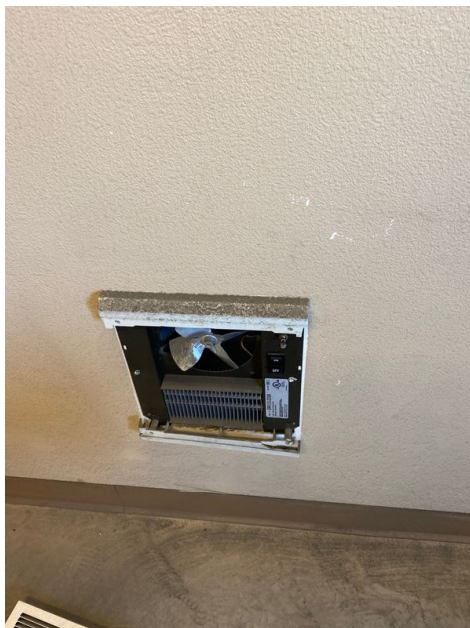
5.9.1 ADDITIONAL DISCOVERIES

SPACE HEATERS

The space heaters at the west offices were not functional at the time of the inspection.

Recommendation
Contact a qualified professional.

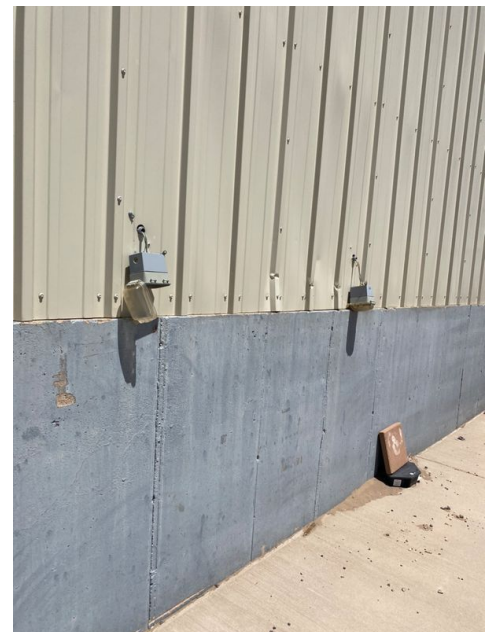
6.4.1 CONNECTED DEVICES AND FIXTURES

DETACHED BUT WITH CURRENT

Two of the exterior outlets at the north side are loose or detached from the wall.

There is current at both outlets when tested. The outlets need to be secured.

Contact a qualified professional.

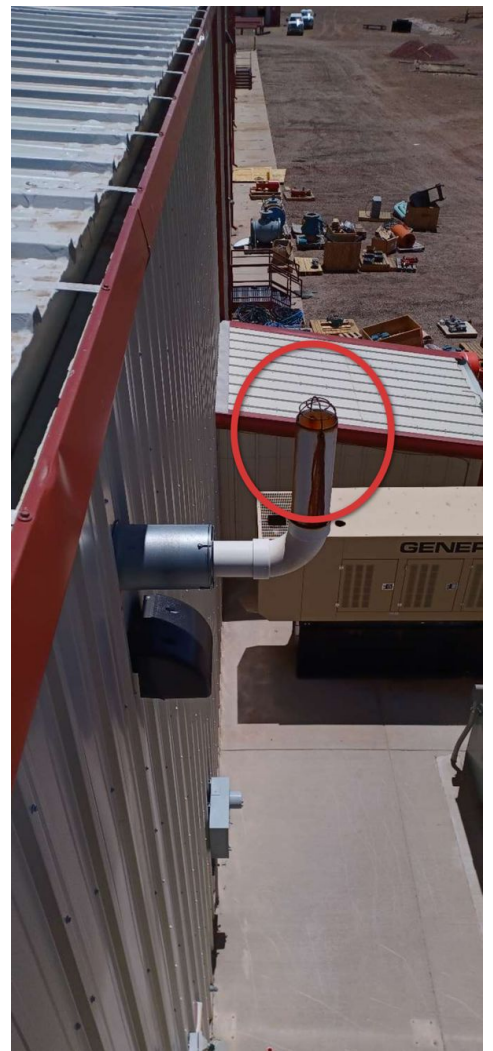
7.3.1 EXHAUST SYSTEMS

SPACE HEATER EXHAUST

The exhaust for the warehouse heater at the northwest exterior of the building is turned up and is catching rain/snow which will damage the heater unit.

It is recommended that a hooded cap be installed or the pipe be cut to exit straight out.

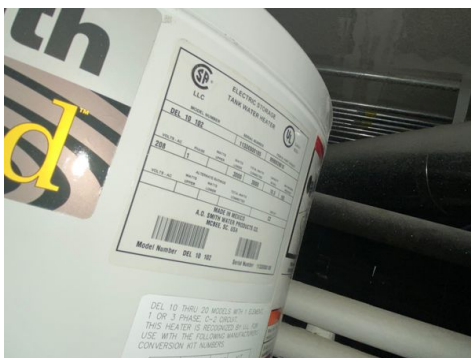
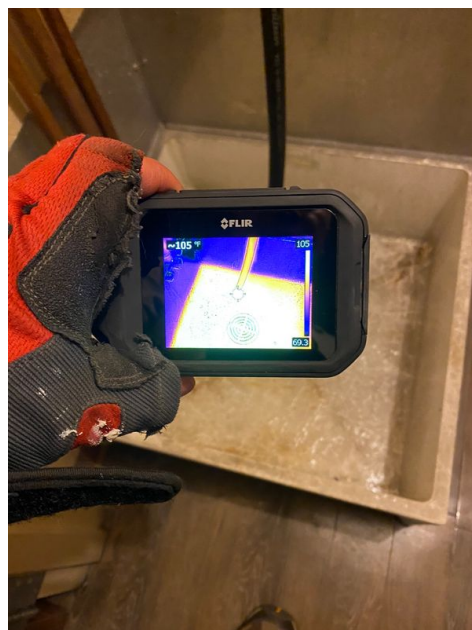
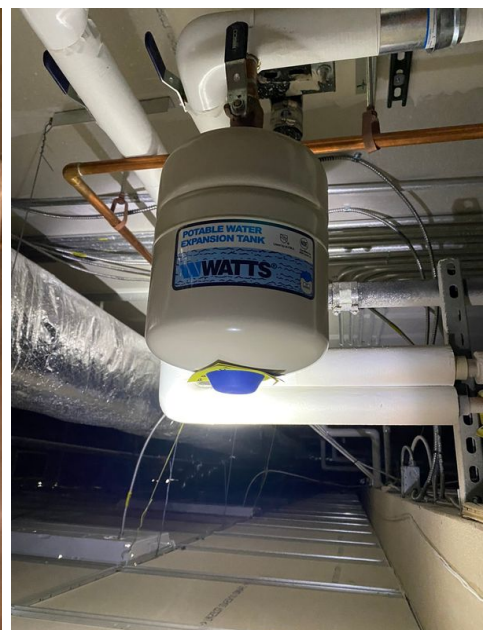
8.7.1 WATER HEATER

The 10 gallon electric water heater was functional at the time of the inspection.

The expansion tank has a saturated bladder and needs to be replaced.

Keep in mind that age of the water heater (11 yrs old), A replacement should be budgeted for.

Contact a qualified professional.

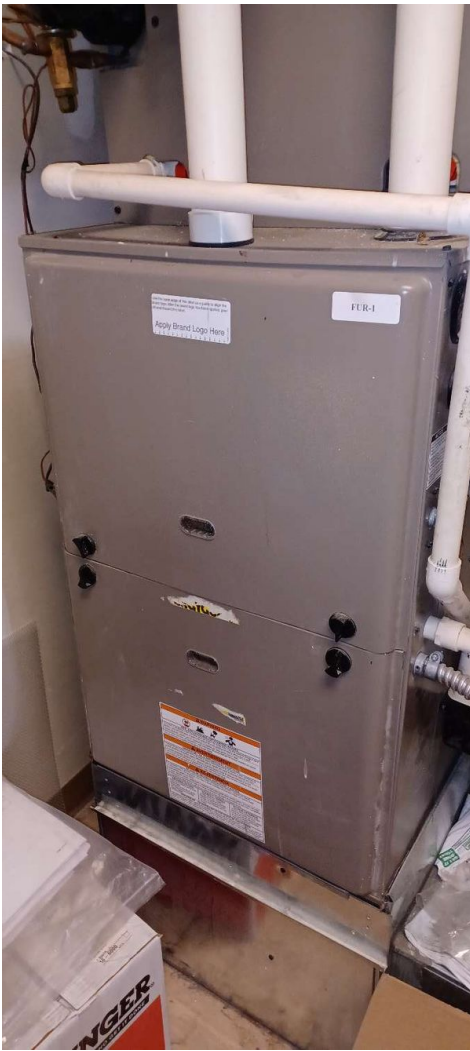
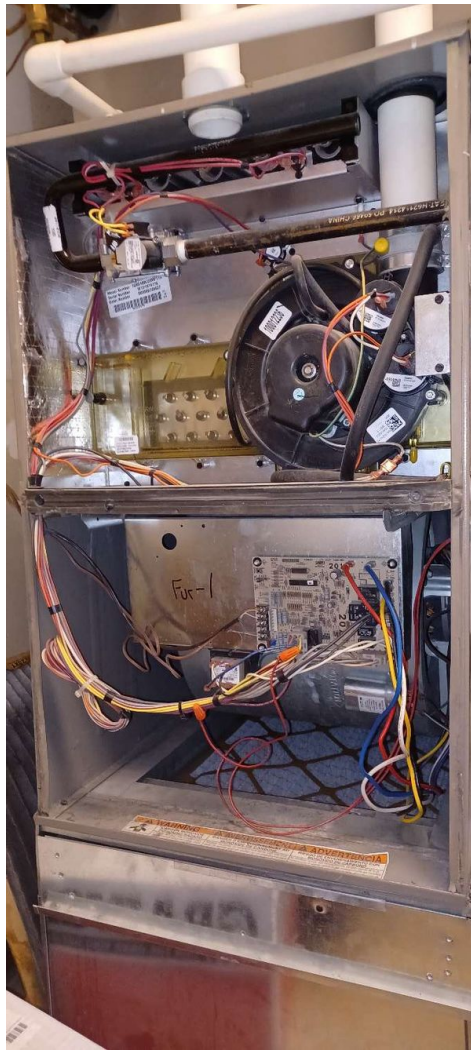
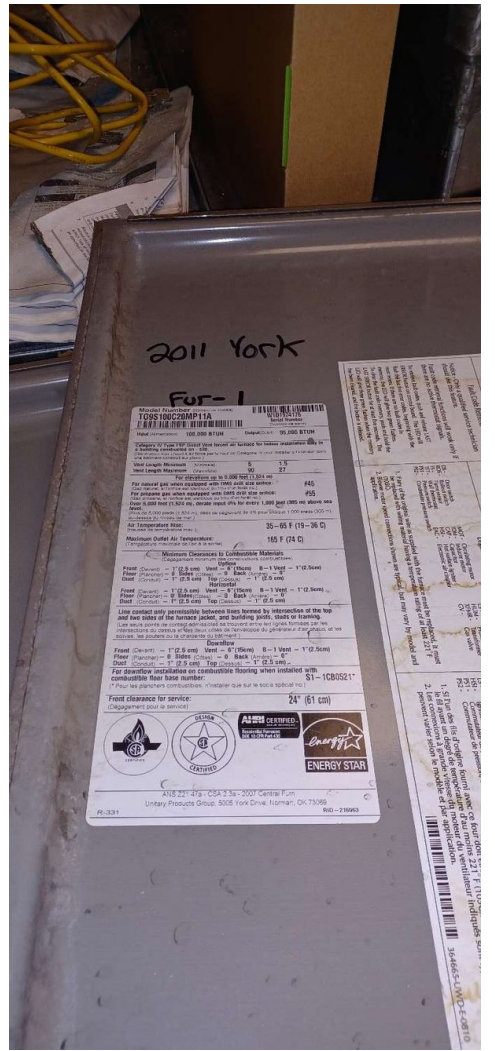
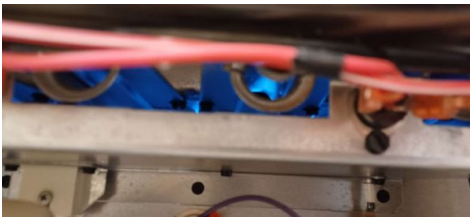
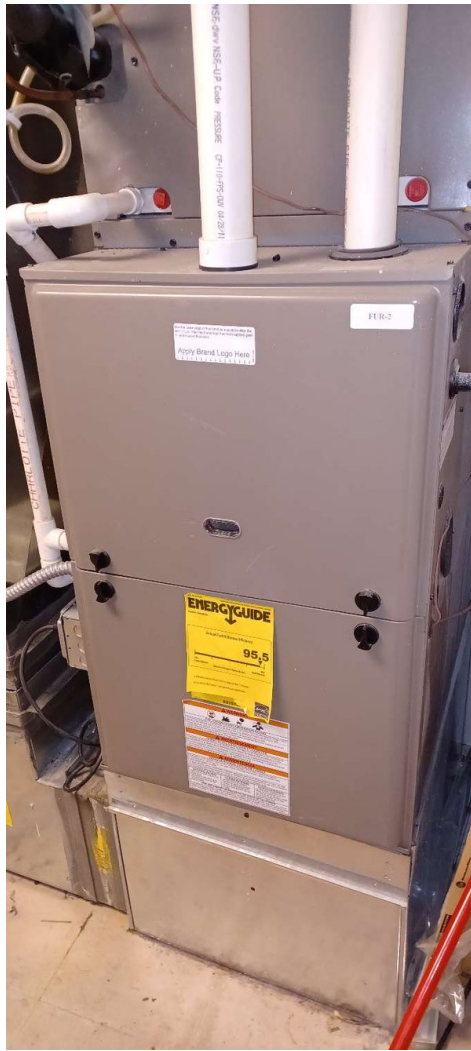
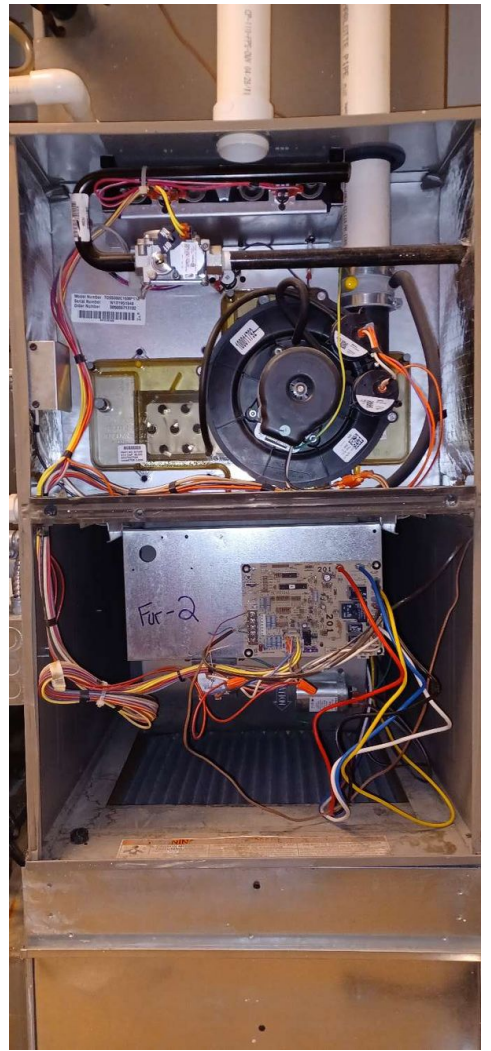
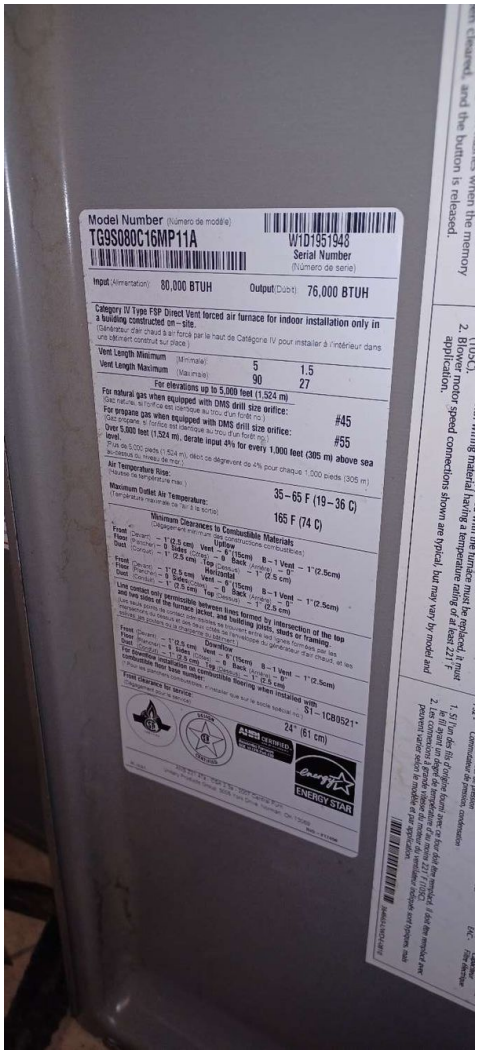
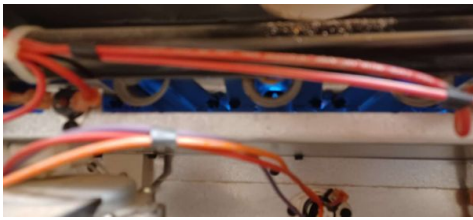
9.1.1 HEATING EQUIPMENT RECOMMEND SERVICING

The gas furnaces were functional at the time of inspection.

However, given the age of the furnaces (11 yrs), it is recommended that a qualified HVAC technician service the units.

Contact a qualified professional.

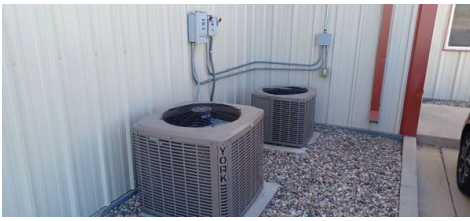
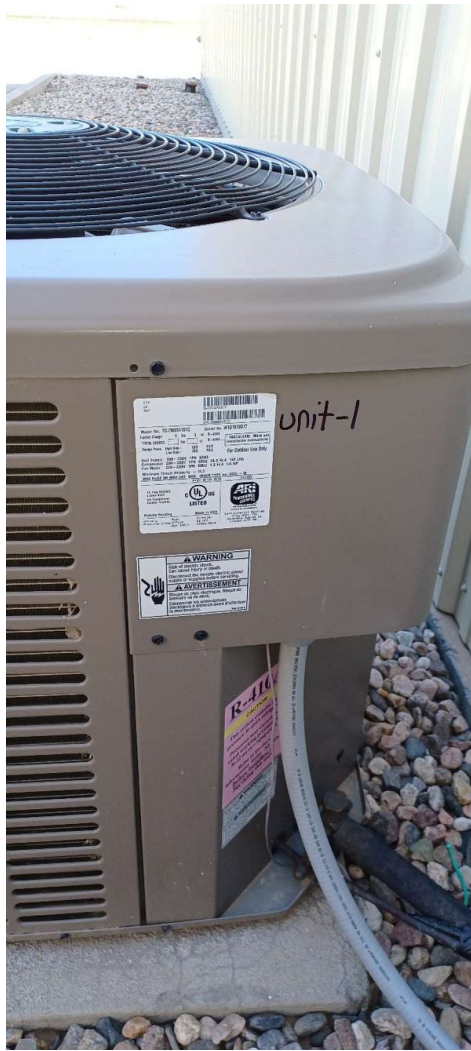
9.6.1 COOLING AND AIR HANDLER EQUIPMENT
NOT FUNCTIONAL

The 2011 York A/C Unit 1 was not functional at the time of inspection. The condenser did not engage and was locked up when tested.

The shut-off switch for the furnace was turned off as a precaution.

It is recommended that a qualified HVAC technician evaluate and determine the cause and make any needed repairs.

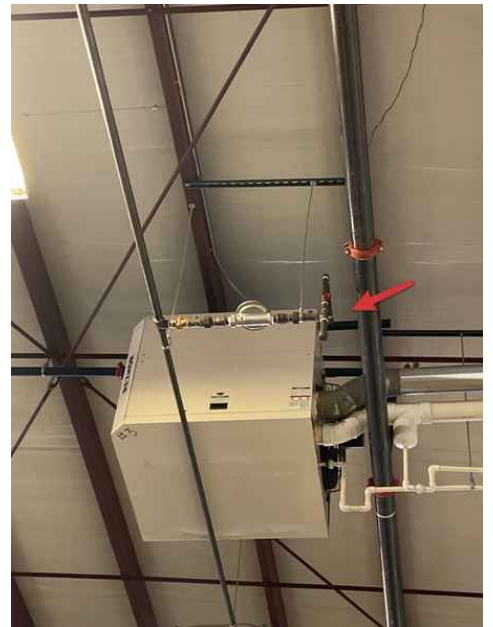
9.10.1 GAS AND ELECTRIC HEATERS FOR WAREHOUSE AND SHOP **NOT FUNCTIONAL**

The gas line to heater No 3 is not installed. The gas heater cannot be tested for function.

Recommendation
Contact a qualified professional.

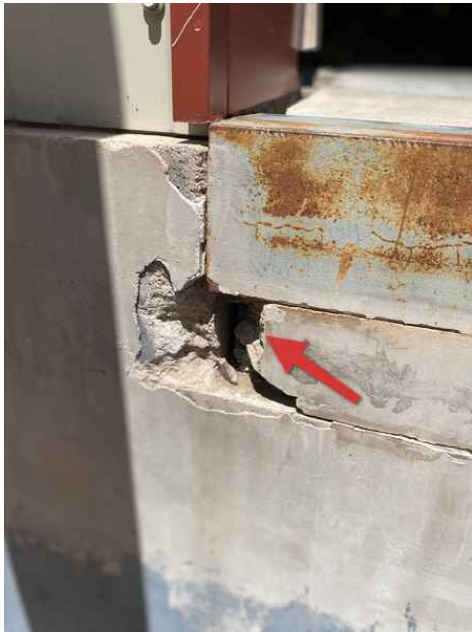
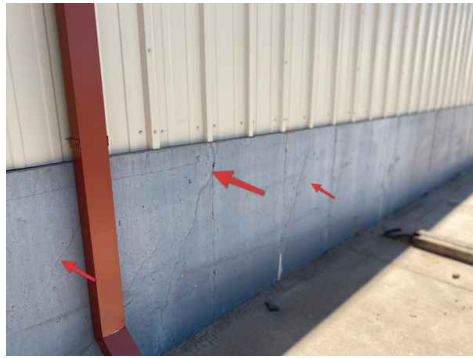
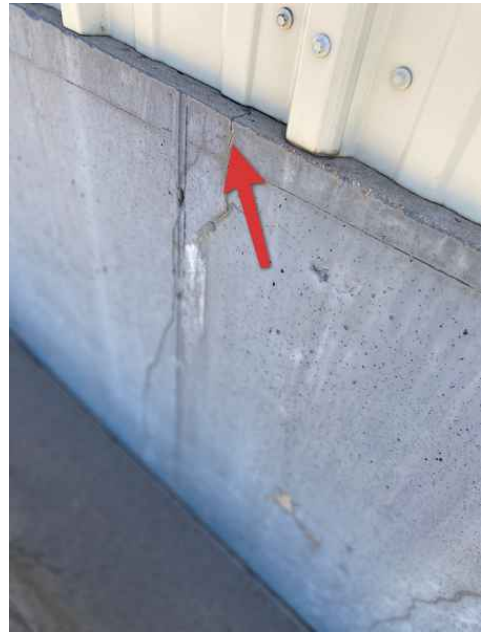
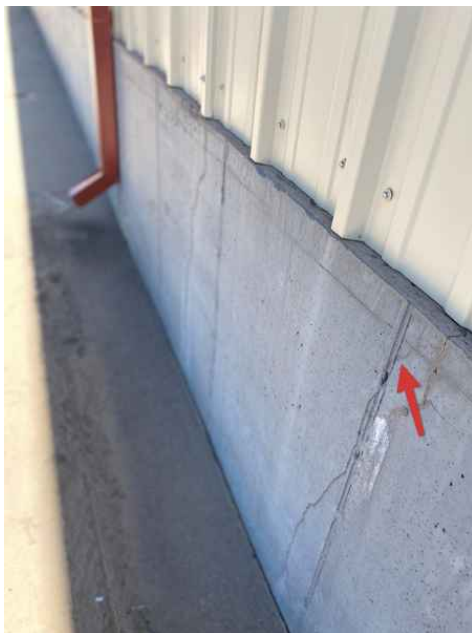
10.1.1 FOUNDATION **FOUNDATION CRACKS - MINOR**

Minor cracking was noted at the exterior of the foundation. These should be sealed to minimize freeze/thaw damage.

Recommendation
Contact a qualified structural engineer.

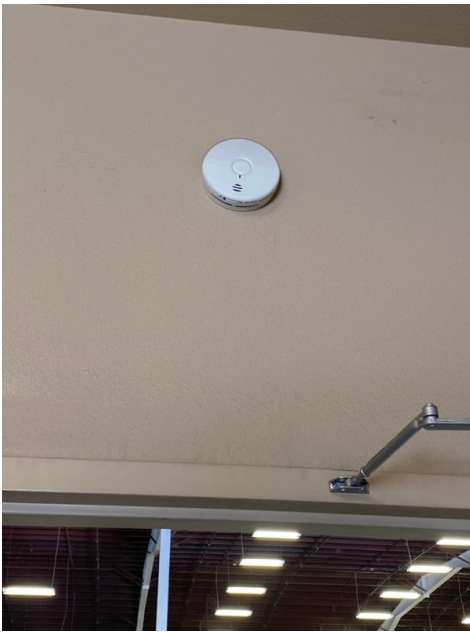
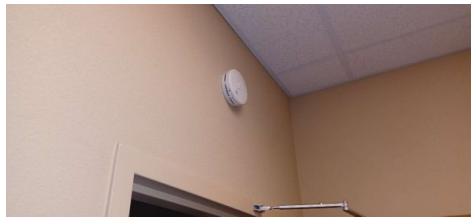
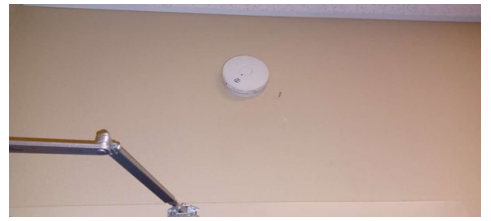
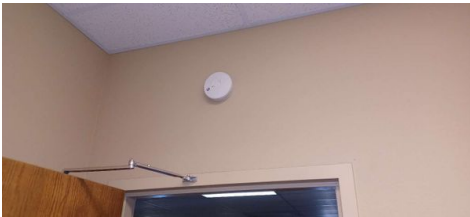
11.7.1 Smoke Detectors

It is recommended that detectors more than 10 yrs old be replaced and that detectors be installed to meet existing standards.

Recommendation
Contact a qualified professional.

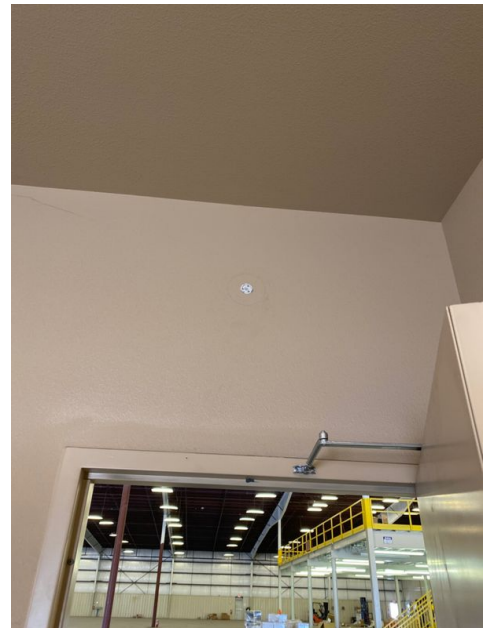
South office

NO CO DETECTOR

There are no carbon monoxide detector found in the office spaces.

It is recommended that detectors be installed according to the manufacturer's instructions.

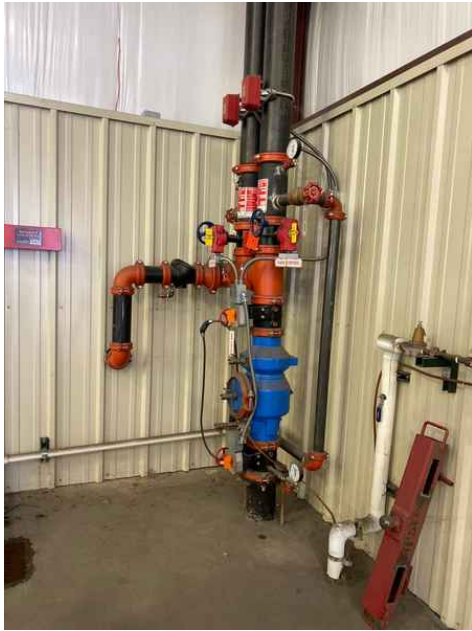
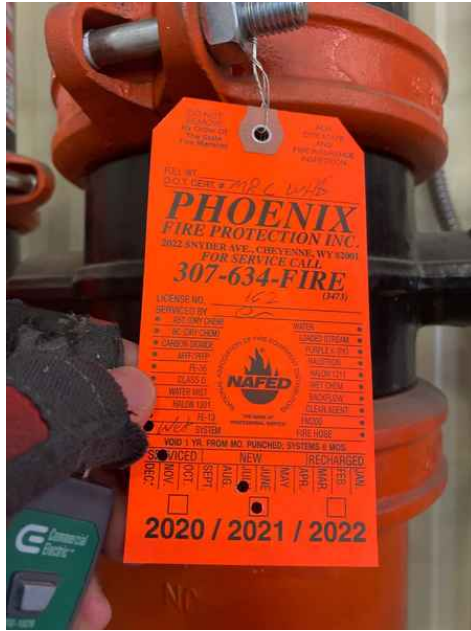
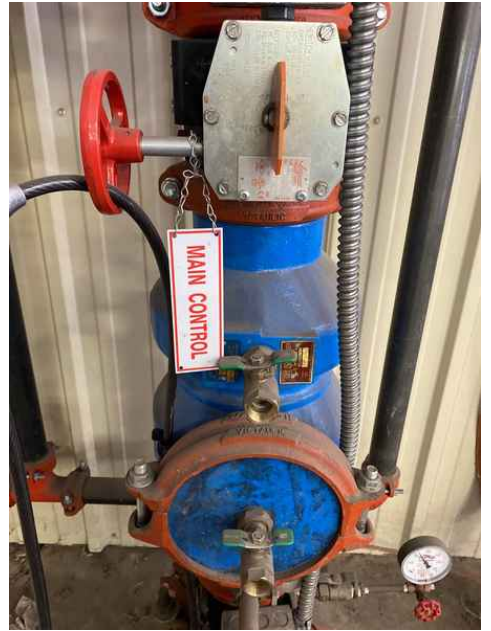
11.11.1 Fire Sprinkler System INSPECTION

Keep in mind that the Fire Sprinkler system was inspected on 07/2021.

The Annual inspection should be scheduled next month.

Contact a qualified professional.

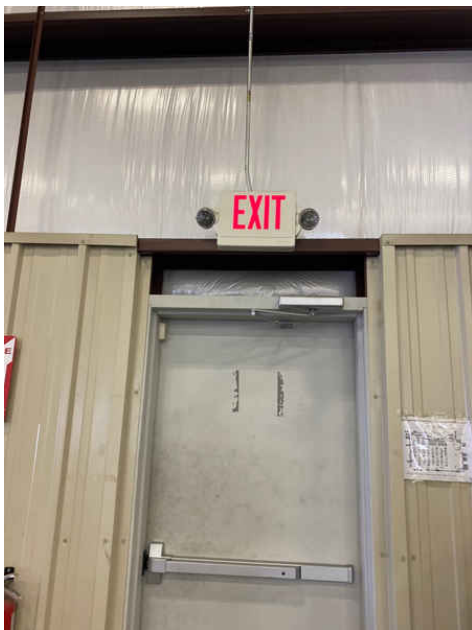
east

NO LIGHTS

There are several (at least 4 units) where the emergency lighting systems did not work when tested.

Contact a qualified professional.
